### **Case Study Details**

- Country: Spain
- Soil Threat: Contamination
- Partners: Evenor-Tech (Partner 9)

# Research progress in remediating soil contamination in the Guadiamar Green Corridor (Spain) event event for soil tech www.recare-hub.eu/guadiamar solutions for soil tech Anaya-Romero, M & Pérez-Alvarez, JM

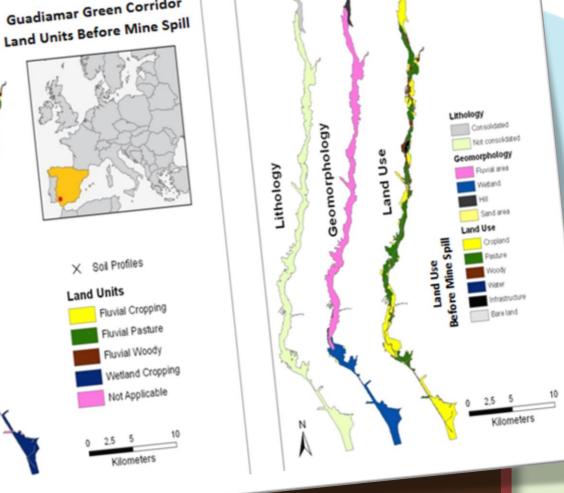
Land units for soil data extrapolation. Soil properties of 18 sampling areas Contamination data of 872 soil profiles
